## C O R E A C C E P T A N C E C R I T E R I A

### 3500/C175 Engines

## 3500/C175 Engines

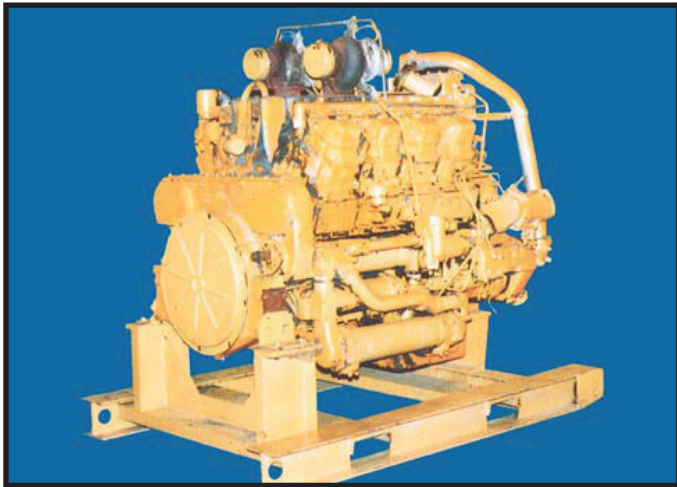
**Figure 1** **Full Core Refund**  
Fully assembled and correctly fastened to metal stand

- **Engine stand:** Engine cores must be returned securely fastened to specially designed 3500/C175 metal stand (see Figures 1 and 2). Core engines must be returned with rear mounts if the engine ordered comes with rear mounts (see Figure 2).

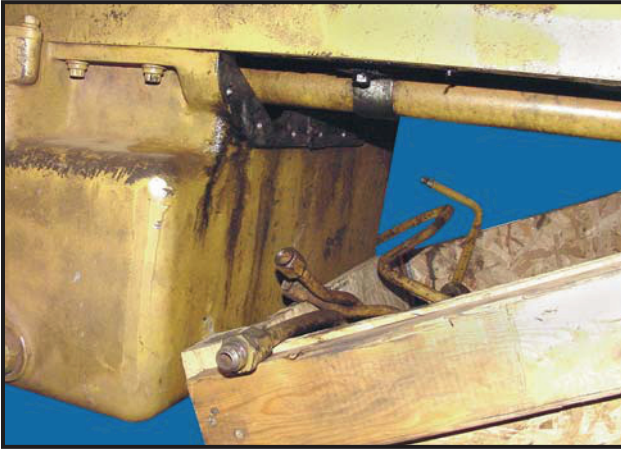
**Figure 5** **Damaged Core Refund**  
Parts not reassembled to core after dealer inspection

**Note:** The engine core must be completely reassembled (not to performance specs) and securely attached to its metal stand prior to shipment. Cores not fully assembled and completed will receive a Damaged Core Refund.

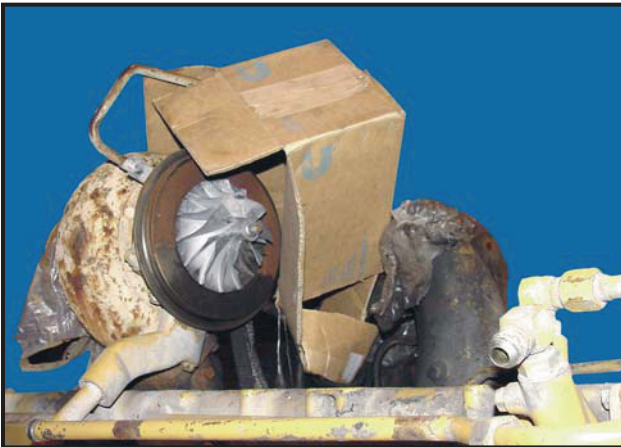
**Figure 7** **Add Charge**  
Missing part – turbocharger compressor housing missing and improper protection from weather

- ◆ Engine block cracked or previously welded (refer to Figures 4 and 12).
- ◆ Crankshaft shows evidence of a spun bearing failure (refer to Figure 8).
- ◆ Upper end failure (i.e. cylinder head casting not salvageable — refer to Figure 6).
- ◆ Missing or non-genuine parts and components (refer to Figure 7).
- ◆ Fluids not properly drained.
- ◆ Not returned on Caterpillar Remanufactured engine stand (refer to Figure 1, 2, and 9).
- ◆ Missing rear mount (refer to Figure 2).
- ◆ Missing or welded main caps (refer to Figure 11).

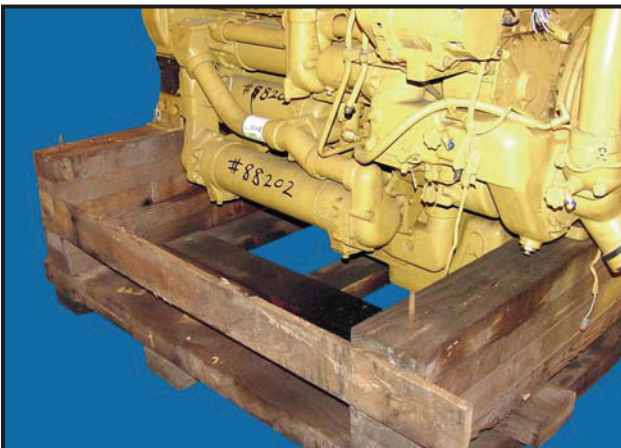
**Figure 9** **Add Charge**  
Core not returned on correct stand

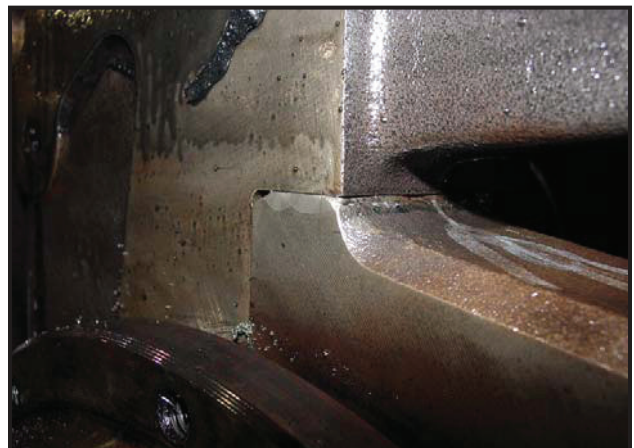
**Figure 10** **Add Charge**  
Welded main caps

For cracked blocks or for blocks that have been successfully salvaged and used again by the customer, Caterpillar will apply the applicable core refund with an Add Charge for cracked or salvaged block. Blocks that appear to have been weld repaired but not put into operation (unsuccessful attempt to salvage) will only be eligible for a Damaged Core Refund. Blocks that we recover as core that are cracked, broken, or welded are all scrapped and recycled through foundries. Cat Reman will only make weld repairs to fix minor cosmetic damage and thus will only accept the same kind of weld repairs for Full Core Refund (see Figure 13). Salvage repair to the main cap of the cylinder block of the engine that complies with the Caterpillar published guidelines will not affect the core refund. Salvage repair to the main cap that does not comply to the guideline, such as welding, will result in an Add Charge per cap (refer to Figures 10 and 11).

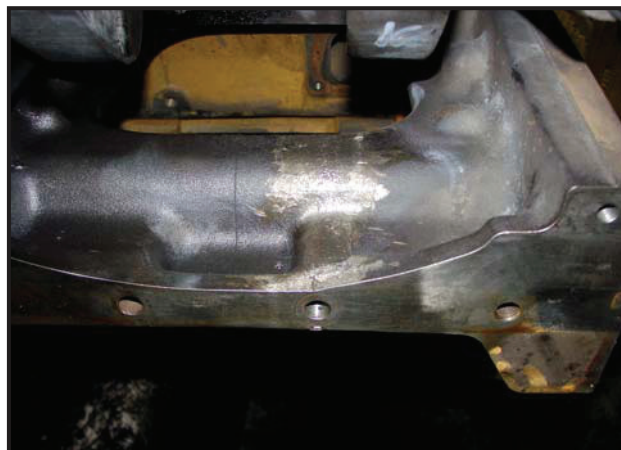
**Figure 12** **Add Charge**  
Cracked/welded

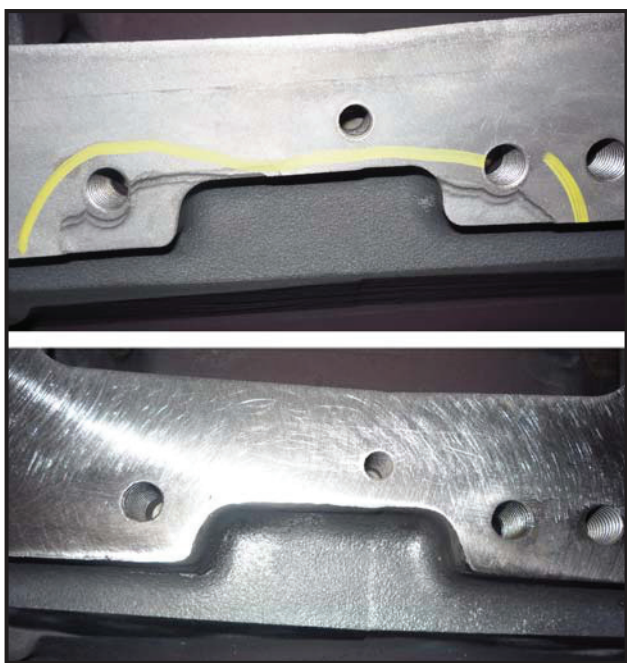
**Figure 13** **Full Core Refund**  
Cosmetic damage/repair
